Repair / Inspection report

Order no.: 212173
Client: Fontexx import/export
Crane: Jost JT 312
Serial no.: 018

Order no.: 212173
Date of repair: 3 – 11 May 2021
Place of repair: Bergeijk
Client: Fontexx import/export
Order no. Client:
Crane: Jost JT 312
Serial no.: 018
Specification: ANSI / AWS D14.1 2005
ASME V, VIII 2007
EN ISO 5817 2014
EN ISO 17637 2017
EN ISO 3834-2 2005

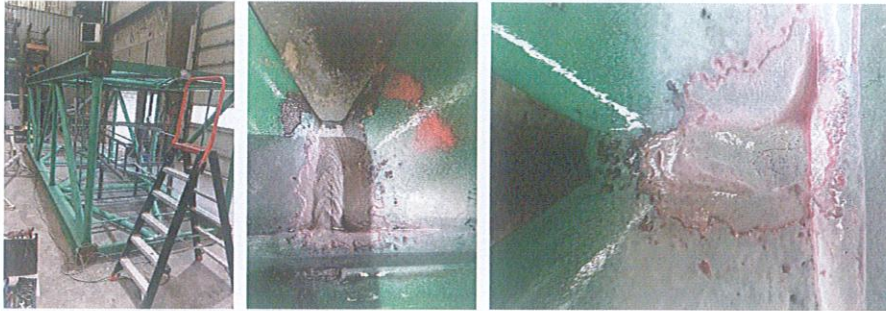
Upon inspection the following damages were found:
Several cracks.

- Grind out the cracks and check by MPI method if cracks are completely removed.
- Prepare groove for welding.
- Weld the cracks.
- Check the new welds by MPI method for cracks and/or indications.

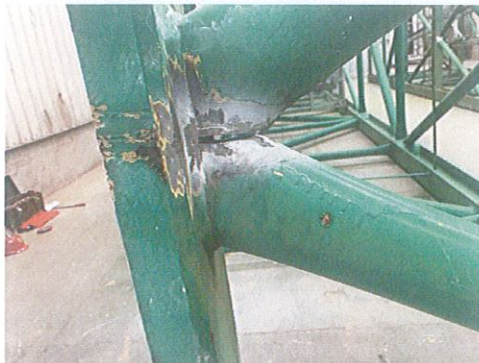
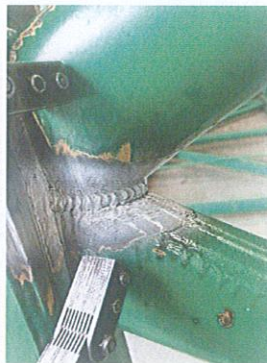
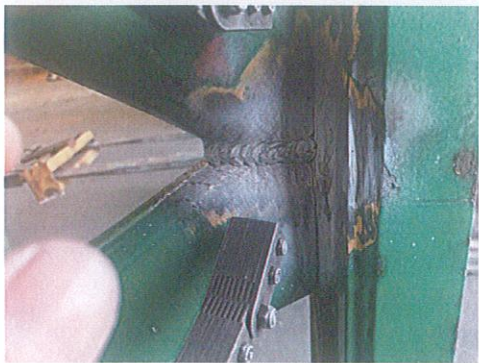
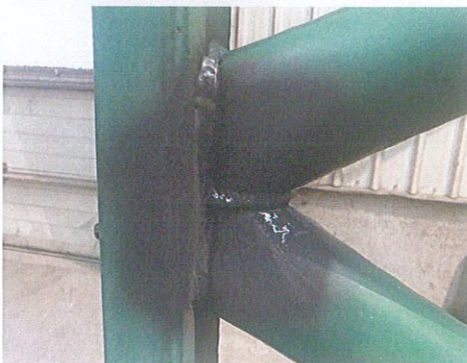
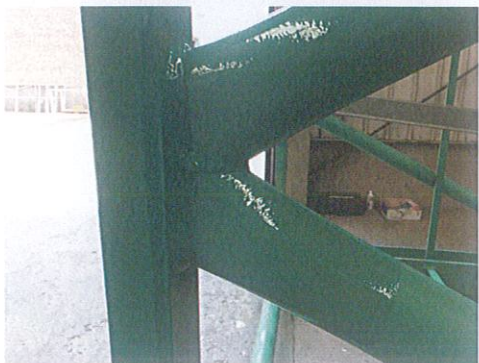
MPI examination has been performed using the MPI test method in accordance with EN ISO 17638. At the time of inspection no relevant indications were observed. The results of this examination met the requirements of EN ISO 23278, level 1.

All relevant dimensions were checked and found to be within the tolerance in accordance with EN ISO 13920 class BF. The dimensions found are such that the repaired parts can be mounted on the original equipment, if applicable.
